Jan 2013- Oklahoma City Minor injuries - One home destroyed, many others damaged No basement, no sewer line breach found Sub-contractor installing telecom lines parallel to gas line

Feb 2013 -- Detroit

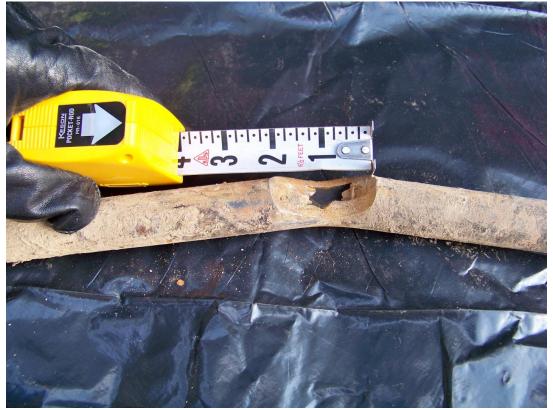
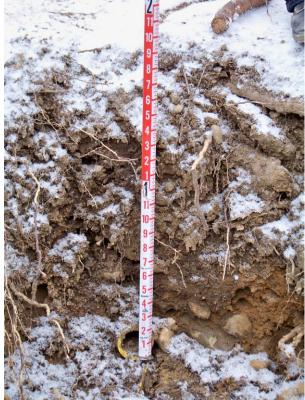
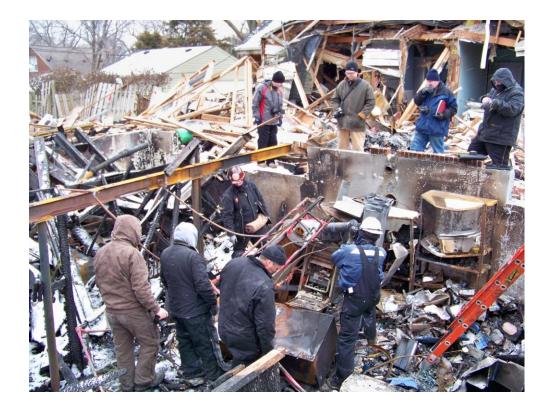
One death -- Two or three homes destroyed, many others damaged Basement, no sewer line breach (sewer lines in the alley) Gas company crossing service lines with new main, report states that service lines at crossings were not exposed

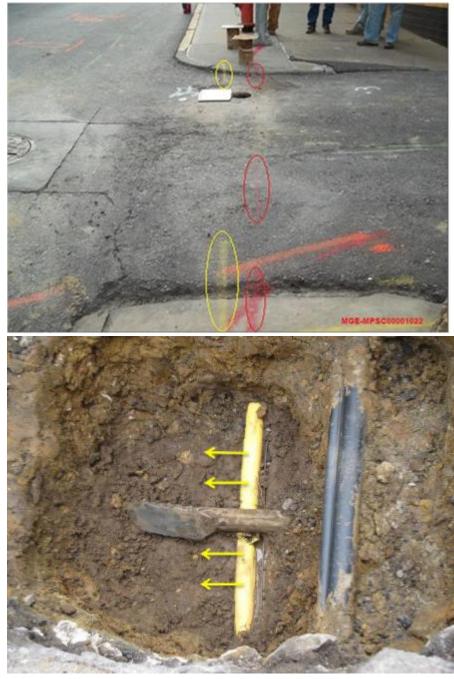
One death, multiple serious injuries -- Business destroyed, many buildings damaged Basement unknown, sewer lines unknown

Contractor installing telecom line across gas line, according to official report the contractor assumed locates were off when they found two lines together that had been marked as one.

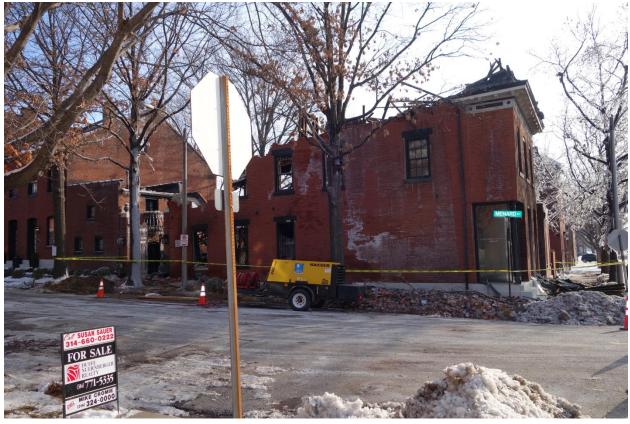
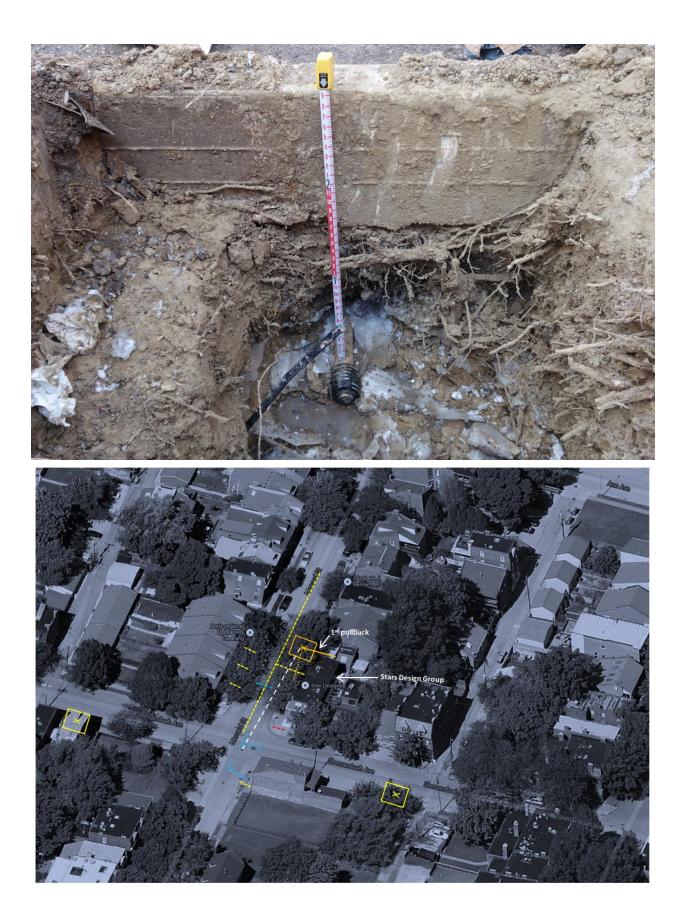
No injuries (14 people evacuated less than 1 min prior to explosion) -- Building destroyed Sub-contractor installing telecom lines, crossed a gas service line, snow on the ground covered locates
