CH4 Connections

What's Going on Underground?

By Roger C. Carson II

Operating Supervisor, Con Edison

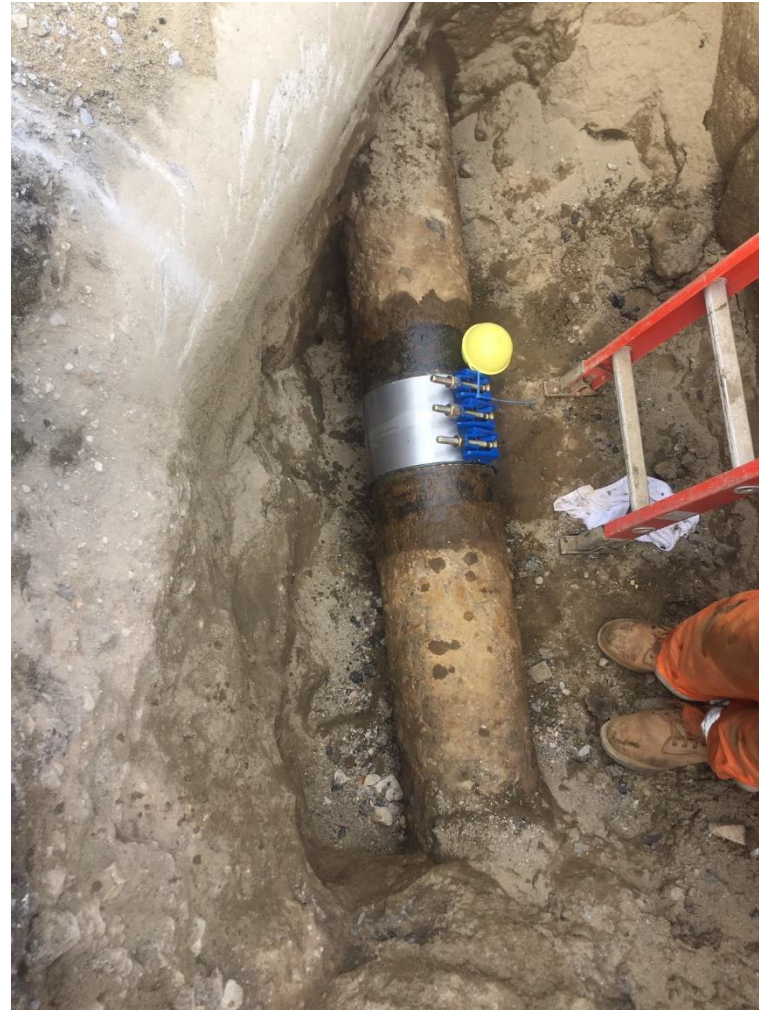
Type 3 Example (cont.)

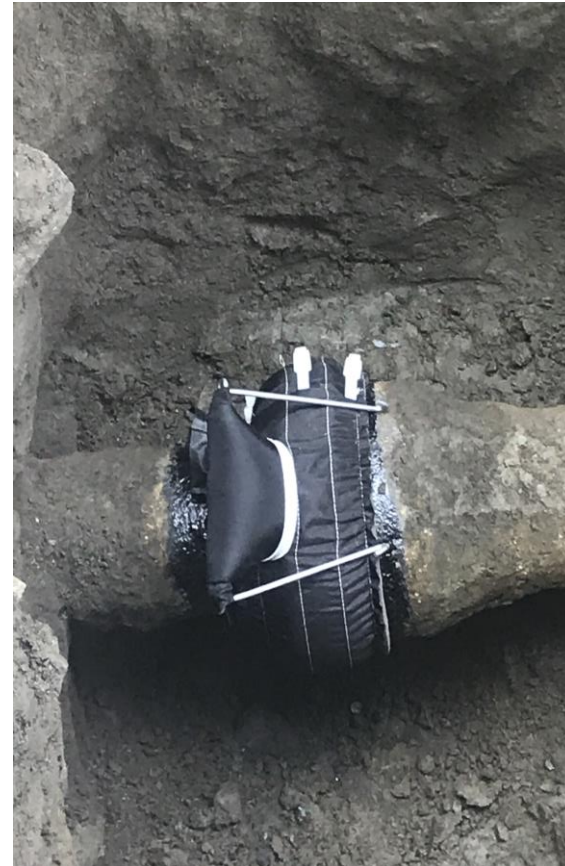
Type 1 Example (cont.)
