CH4 Connections

What's Going on Underground?

By Roger C. Carson II

Operating Supervisor, Con Edison

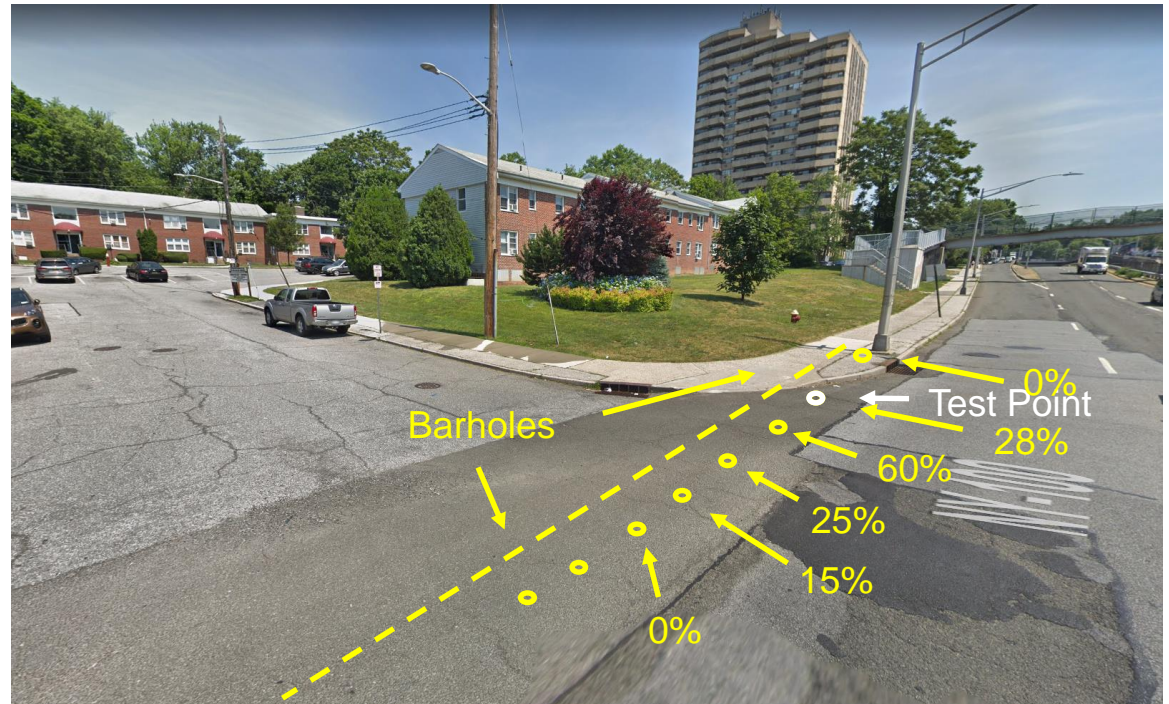
- Main:
 - 10" HPST 1971
- Road Makeup:
 - Asphalt
 - Concrete
 - Earth

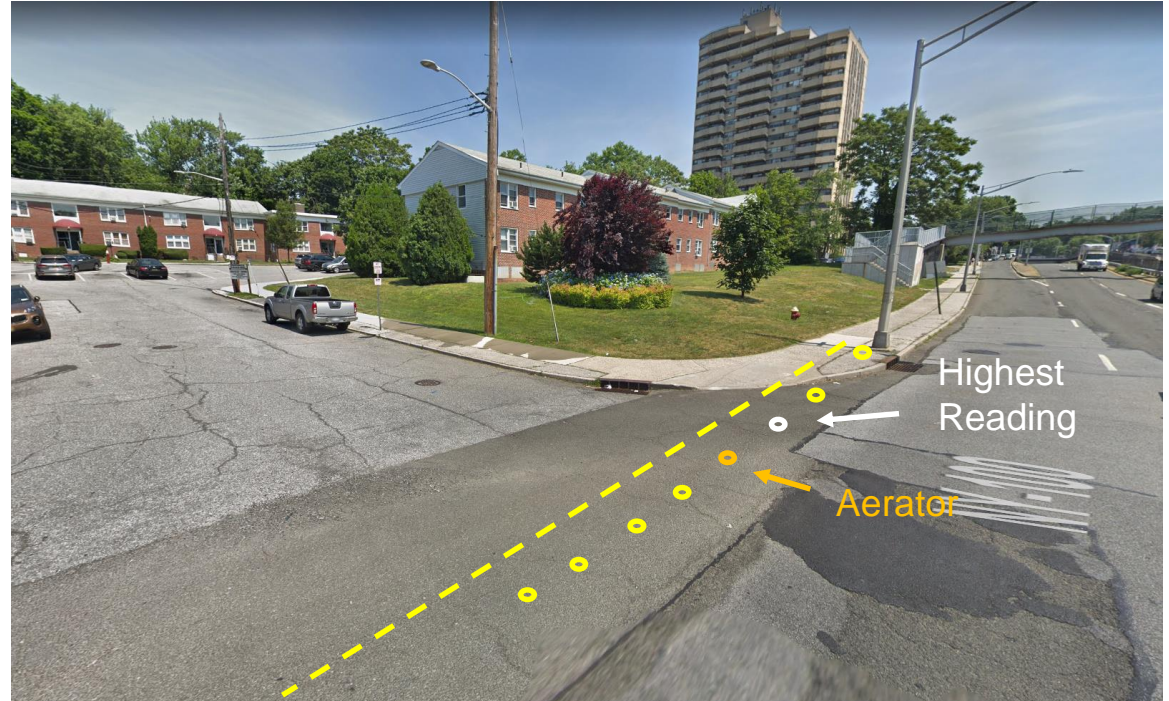
- Main:
 - 10" HPST 1971
- Road Makeup:
 - Asphalt
 - Concrete
 - Earth

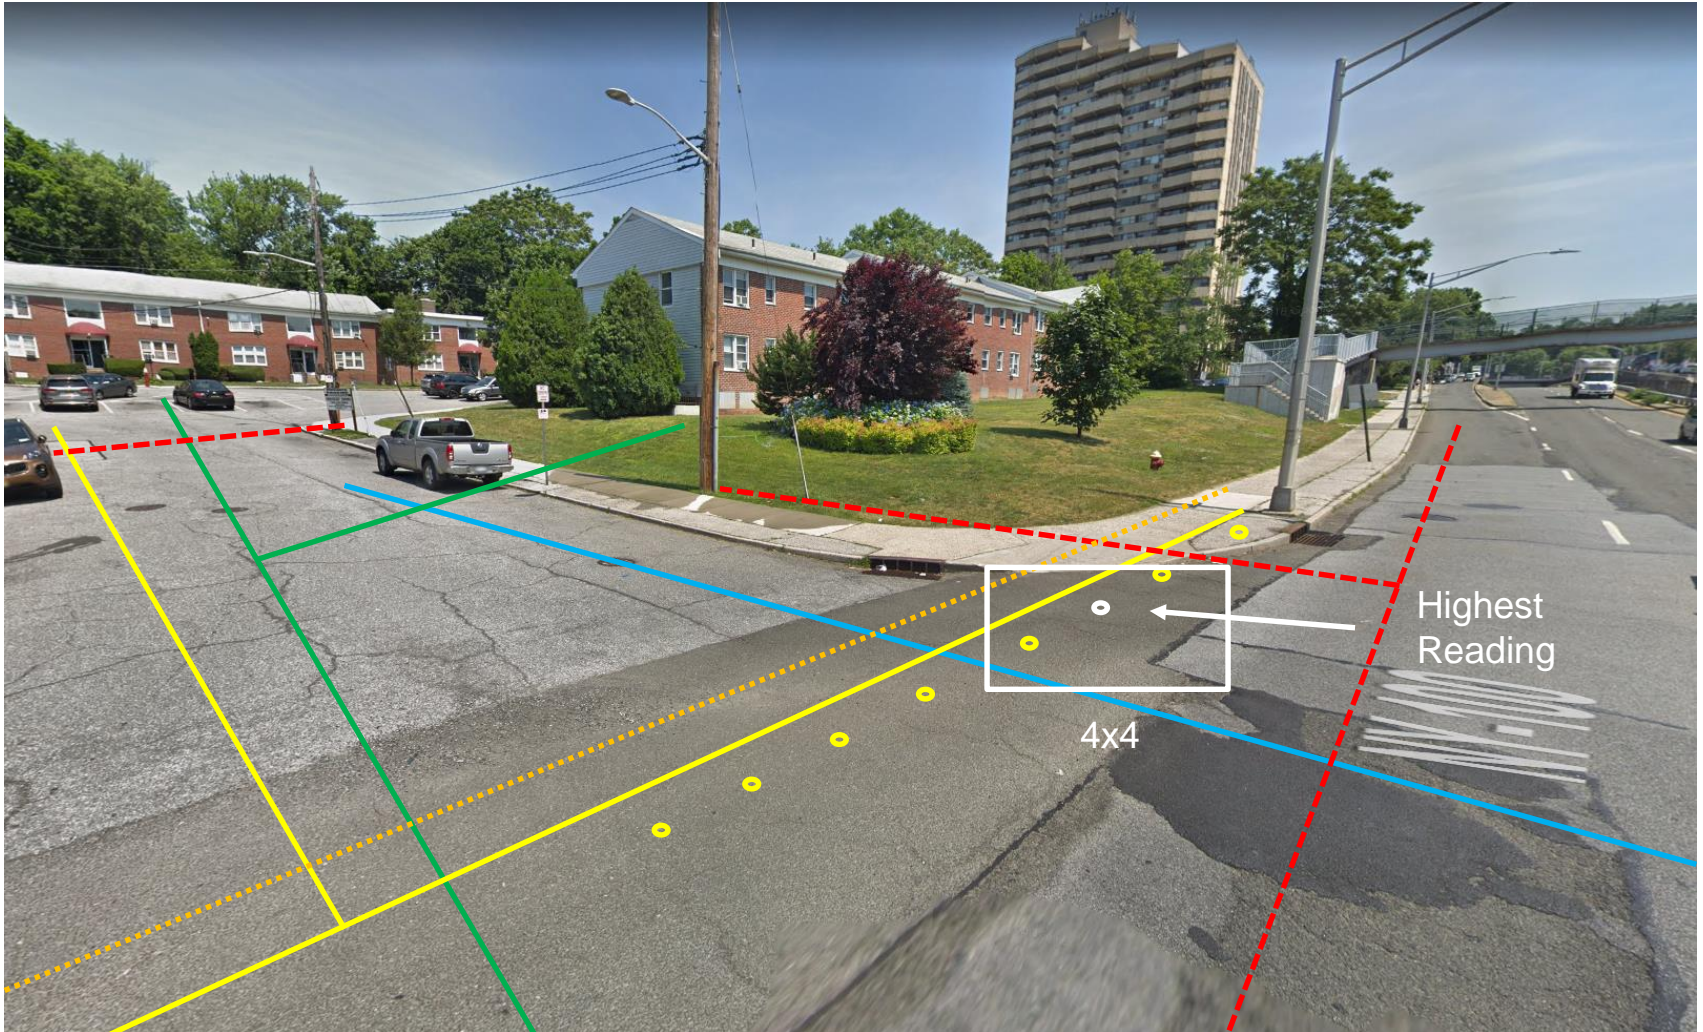
- Main:
 - 10" HPST 1971
- Road Makeup:
 - Asphalt
 - Concrete
 - Earth
- Reason for Leak:
 - Corrosion
- Repair:
 - Fullseal Clamp

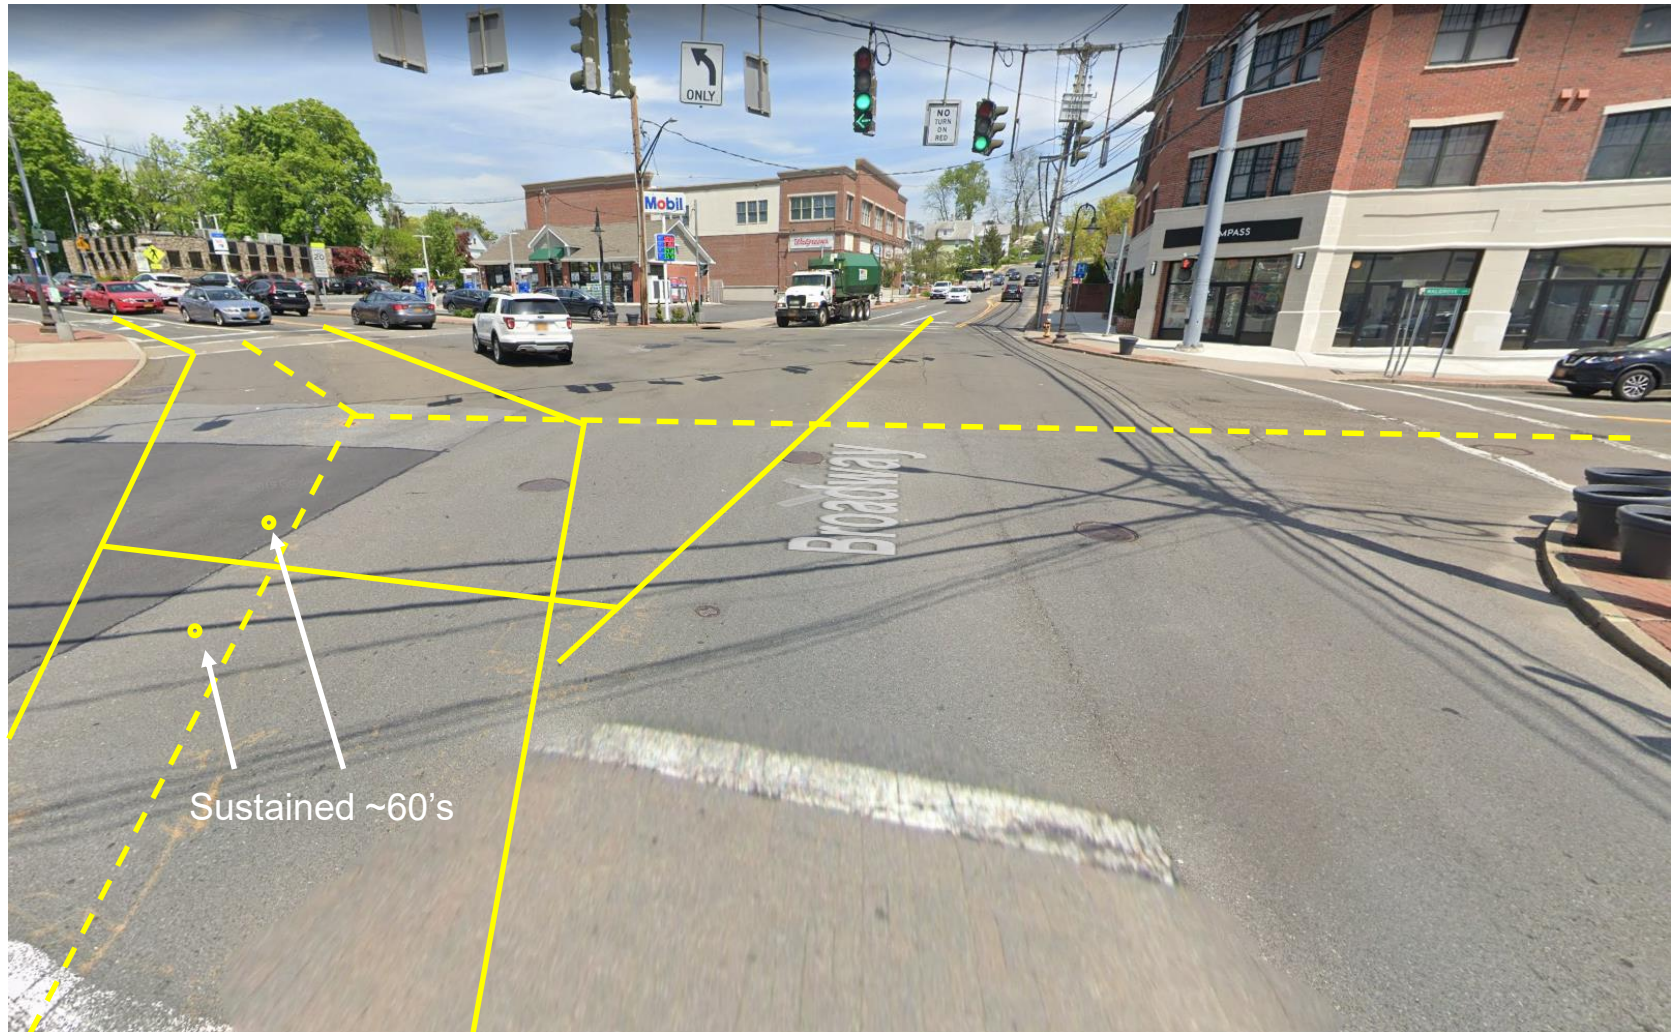
- Main:
 - 16" MPC1 1917
- Road Makeup:
 - Asphalt
 - Concrete
 - Earth/Rock
- Reason for Leak:
 - Bell & Spigot Joint
- Repair:
 - Encapsulation

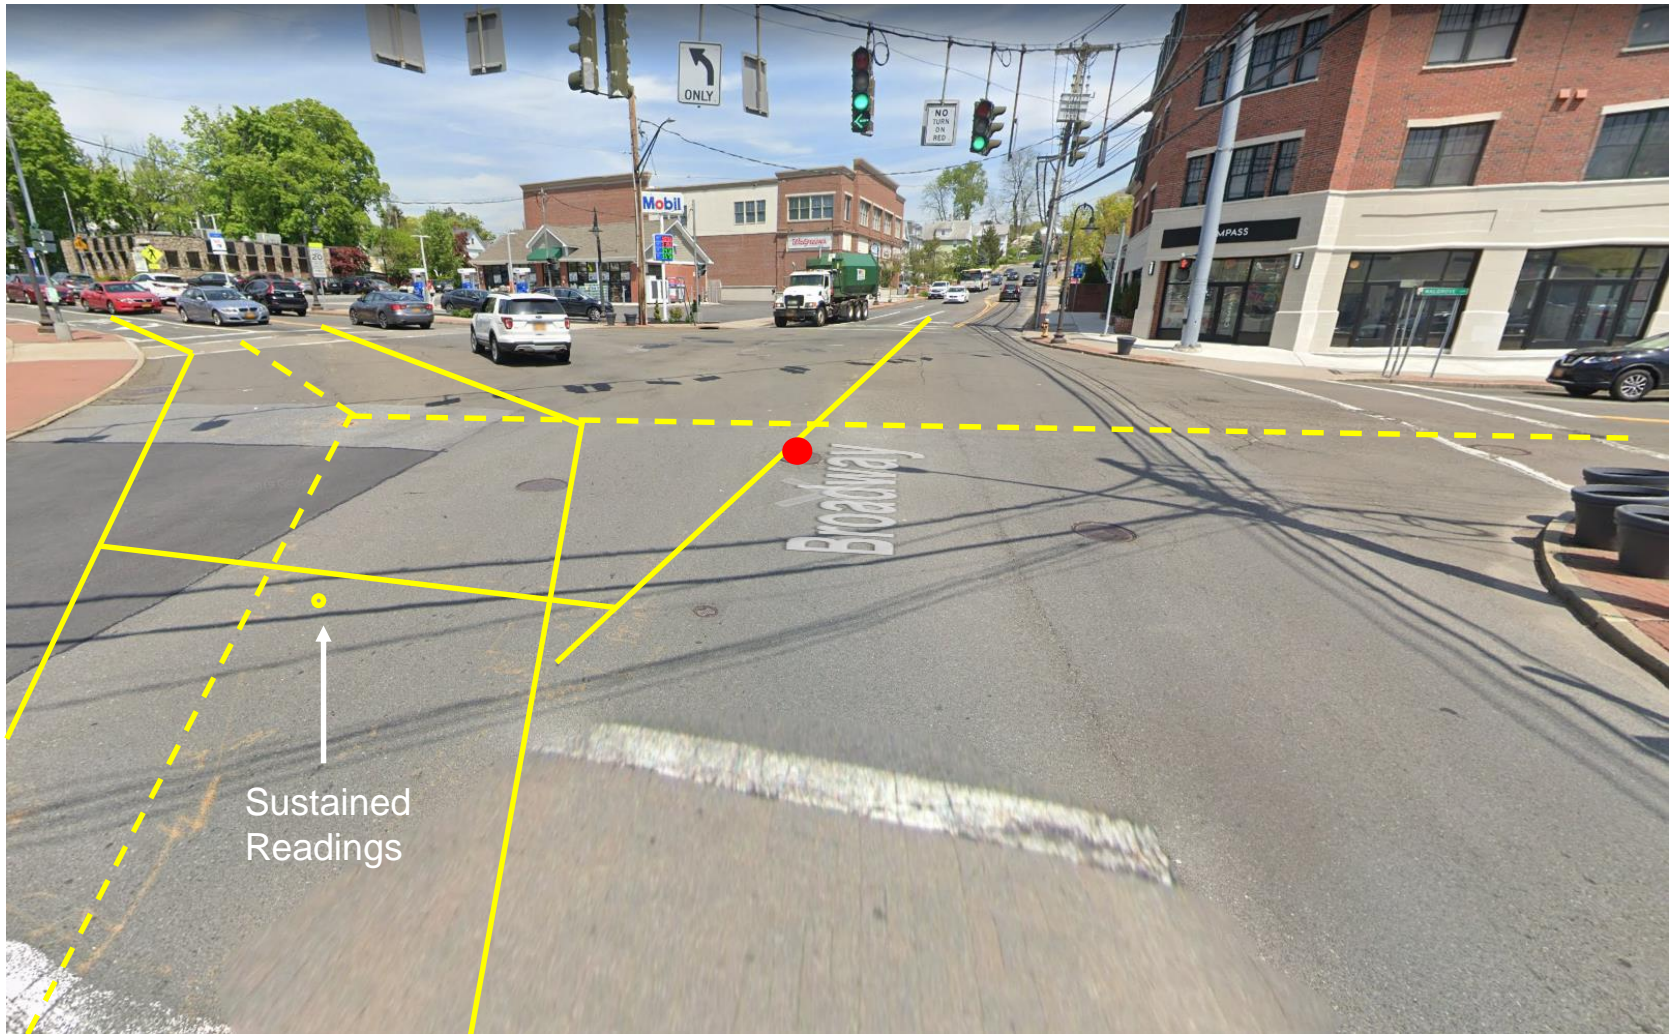
- Main:
 - 6" LPCI 1904
 - 1" Steel Riser
- Road Makeup:
 - Asphalt
 - Concrete
 - Earth/Rock
- Reason for Leak:
 - Corrosion on Riser
- Repair:
 - Replace Riser
